# Where the Water Goes: How Coal Mining Changes the Rivers and Streams of Kuzbass

How open-pit mines, mine dewatering and waste dumps alter channels, catchments and groundwater supply — and why the consequences are often harder to verify than the original project forecast.

| <b>Document type</b> | Independent documentary investigation with an evidence appendix |

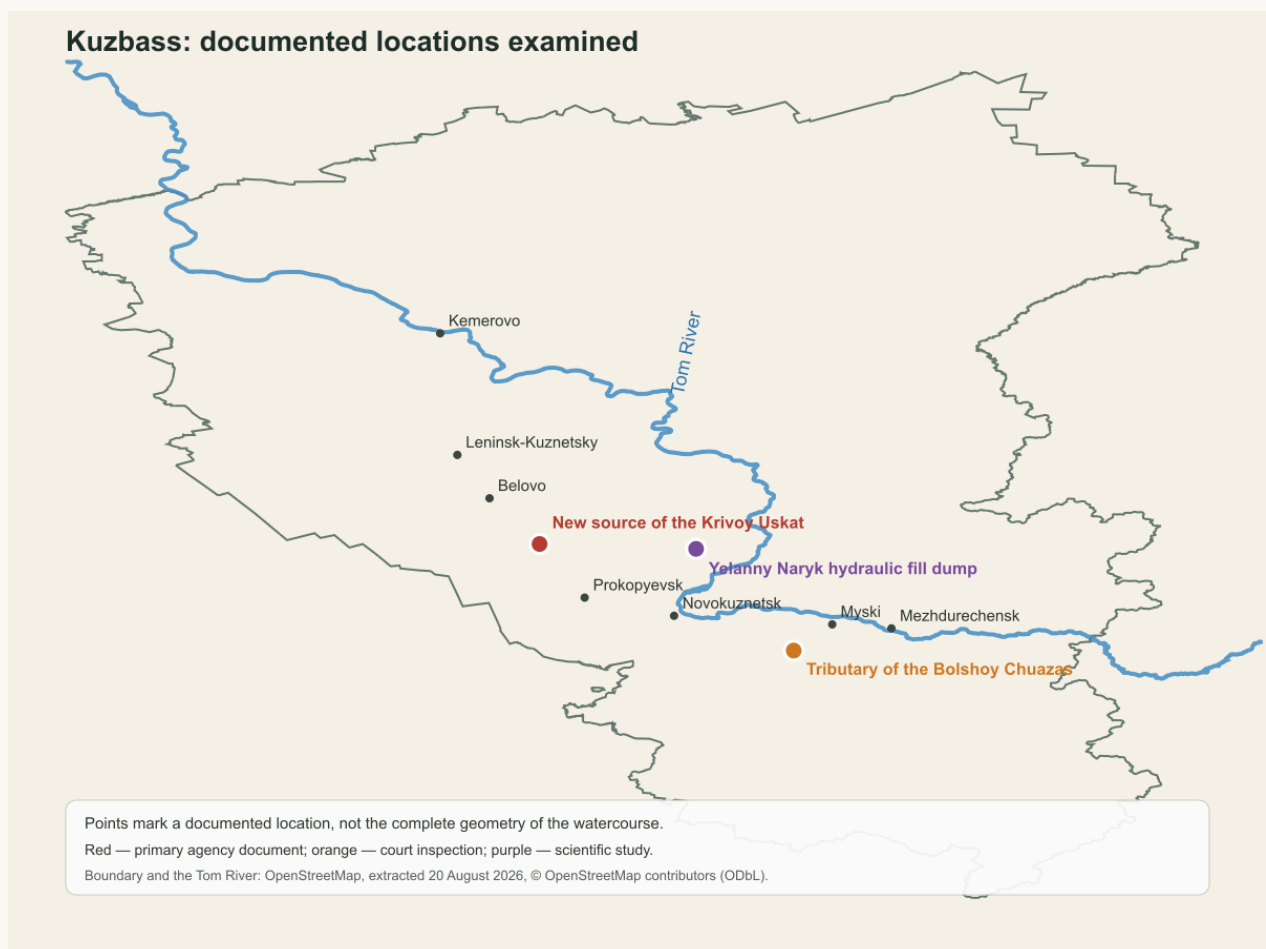
## Documented locations examined

**Overview map.** Points mark documented locations, not the complete geometry of each watercourse. Regional boundary and the Tom River: © OpenStreetMap contributors, ODbL.
